# Manhole Inspection Summary

# Manhole # S45I2\_017MH

Insp Date: **1/9/08 11:24 AM**

**Location** Address: **1429 Church St**

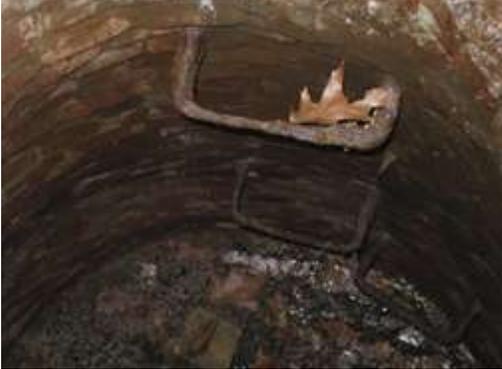
Count: **3** Missing: **1**  **Corroded**

steps

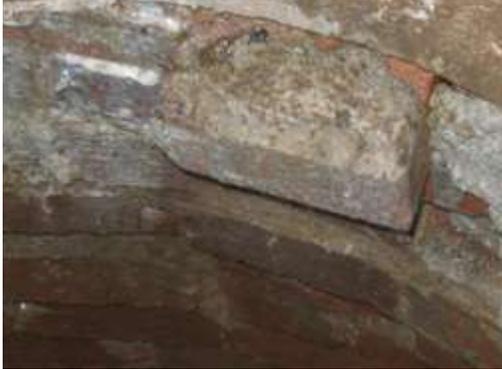
Defect 1

Condition:  Sound  Cracked  Root Intrusion  **Loose Brick**  Deteriorated

loose bricks on chimney

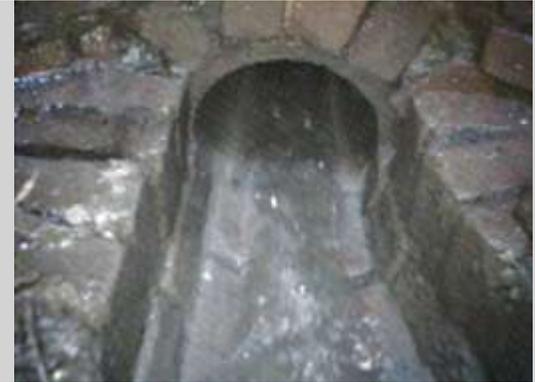
**12 O'Clock Outflow**

Pipe Height: **9.6** (in.) Rod and Bar (Angled)  
Pipe Material: **Clay**  Pipe Lined  
Invert Depth: **8.92** (ft.) Flow Characteristics: **Fast**  
Deposits:  None  Mud  Sludge  Debris  Grease  
Silt Depth: (in.) Deposits Extent:  
Infiltration: **None** Pipe Seal Cond: **Sound**

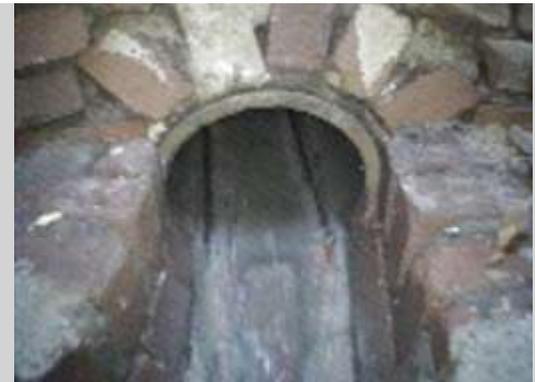
**4 O'Clock Inflow**

Pipe Height: **9.6** (in.) Rod and Bar (Angled)  
Pipe Material: **Clay**  Pipe Lined  
Invert Depth: **8.59** (ft.) Flow Characteristics: **Fast**  
Deposits:  None  Mud  Sludge  Debris  Grease  
Silt Depth: (in.) Deposits Extent:  
Infiltration: **None** Pipe Seal Cond: **Sound**

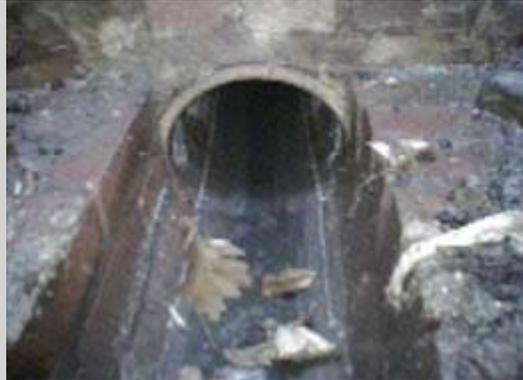
6 O'Clock Inflow

Pipe Height: **10.8** (in.) Rod and Bar (Angled)

Pipe Material: **Clay**  Pipe Lined

Invert Depth: **8.75** (ft.) Flow Characteristics: **Fast**

Infiltration: **None** Pipe Seal Cond: **Sound**
